Manhole Inspection Summary

Manhole # S04YY1014MH

Location Address: **3812 CLARKS LN**

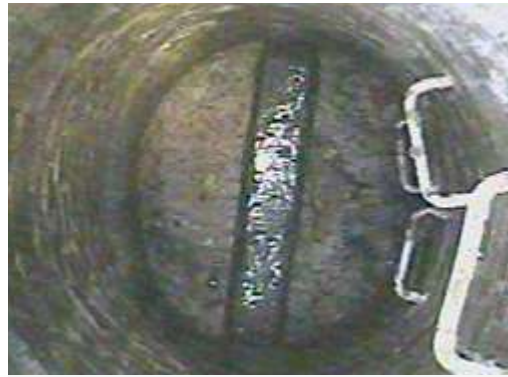
Top View

Adjustment, Corbel, and Barrel infiltration.
Bench debris. Corroded steps.

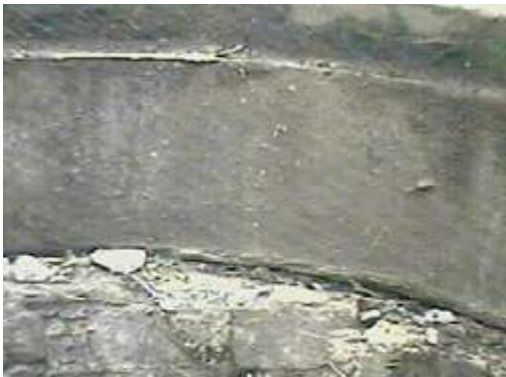
Defect

Frame leaks. Frame offset. Adjustment
loose brick, deterioration and infiltration.

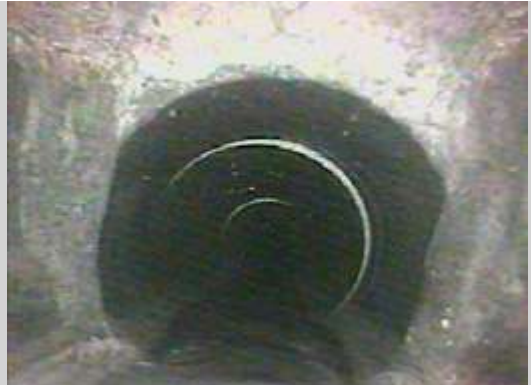
8 in. Circular Gravity Sewer Pipe Out @ 12 O'Clock

Deposits: ☐ None ☐ Mud ☐ Sludge ☐ Debris ☒ **Grease**

Silt Depth: **0** (in.) Deposits Extent: **Light**

Infiltration: **Evidence** Pipe Seal Cond: **Cracked**

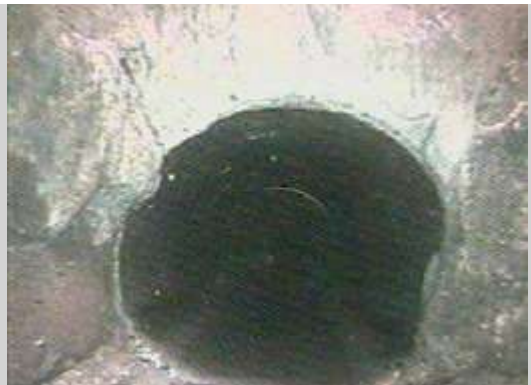
8 in. Circular Gravity Sewer Pipe In @ 6 O'Clock

Deposits: ☐ None ☐ Mud ☐ Sludge ☐ Debris ☒ **Grease**

Silt Depth: **0** (in.) Deposits Extent: **Light**

Infiltration: **Evidence** Pipe Seal Cond: **Cracked**
